Manhole Inspection Summary

Manhole # S05GG1008MH

Location Address: **REAR OF 3928 FERNHILL AVENUE** Cross Street: **GARRISON BLVD**

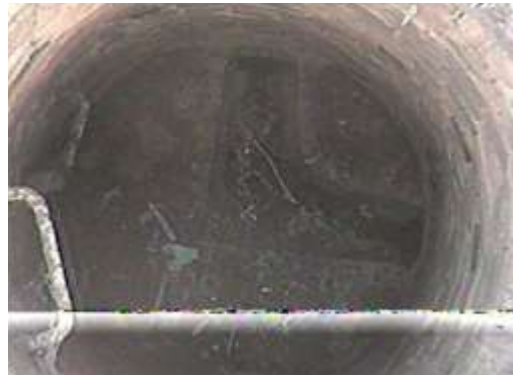
Top View

DEBRIS ON CHANNEL AND BENCH

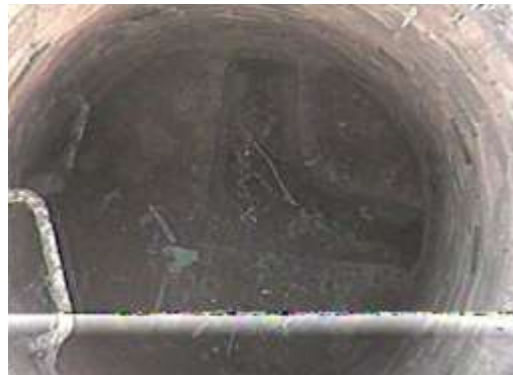
Defect 1

Steps Count: **2** Missing: **0** ☒ **Corroded**

CORRODED STEPS

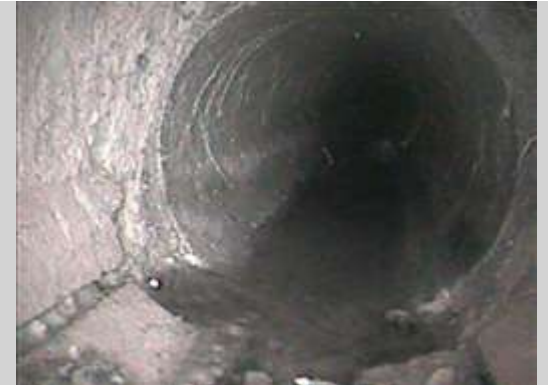
12 O'Clock Outflow

8 in. Circular Gravity Sewer
Pipe Out @ 12 O'Clock

Pipe Height: (in.) Direct
Pipe Material: **Clay** ☐ Pipe Lined
Invert Depth: **6.59** (ft.) Flow Characteristics: **Slow**
Deposits: ☒ None ☐ Mud ☐ Sludge ☐ Debris ☐ Grease
Silt Depth: **1** (in.) Deposits Extent:
Infiltration: **None** Pipe Seal Cond: **Sound**

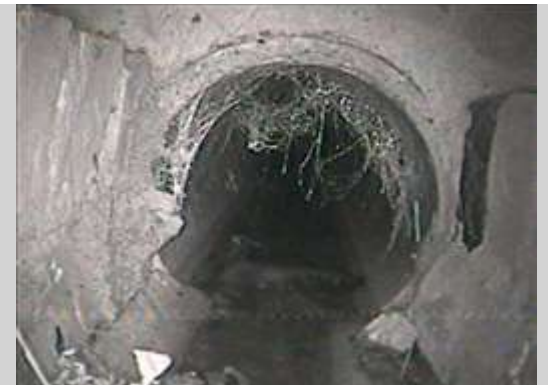
3 O'Clock Inflow

8 in. Circular Gravity Sewer
Pipe In @ 3 O'Clock

Pipe Height: (in.) Direct
Pipe Material: **Clay** ☐ Pipe Lined
Invert Depth: **6.56** (ft.) Flow Characteristics: **Slow**
Deposits: ☒ None ☐ Mud ☐ Sludge ☐ Debris ☐ Grease
Silt Depth: (in.) Deposits Extent:
Infiltration: **None** Pipe Seal Cond: **Sound**
